**RETAINING WALL REPORT
PREPARED
OCTOBER 29, 2010**

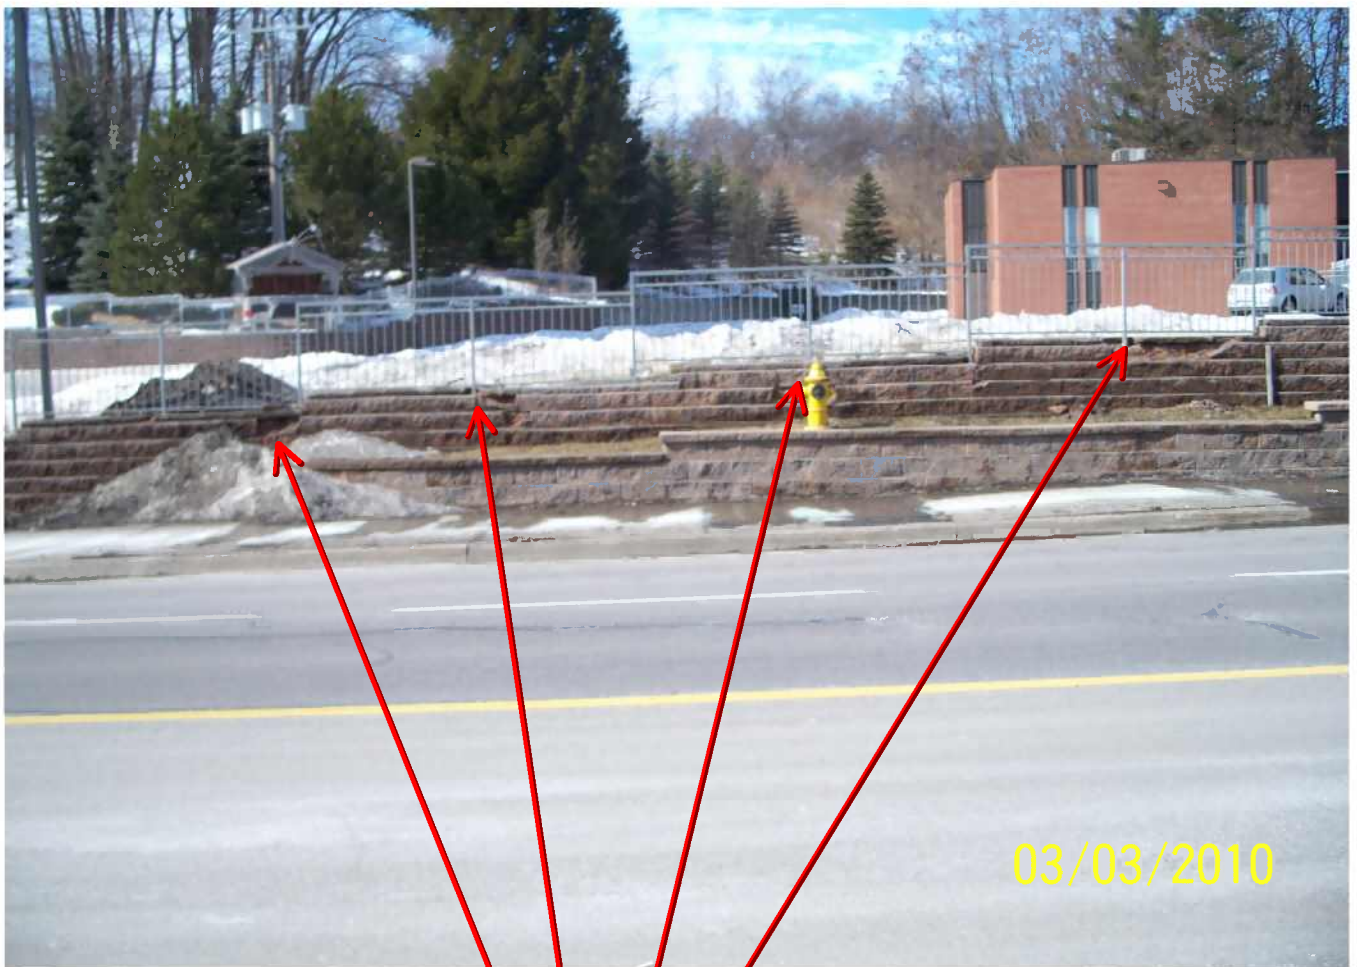
File Photo illustrates deteriorating block on retaining wall. This prompted evaluation of block composition for given application and related exposures (salt, water run-off, wind load from railing etc.)

Deterioration was accelerated at locations where railing was installed in block.

Placement of salt laden snow in proximity to blocks contributed to the problem.

Reconstruction remedies will be discussed later in this package.

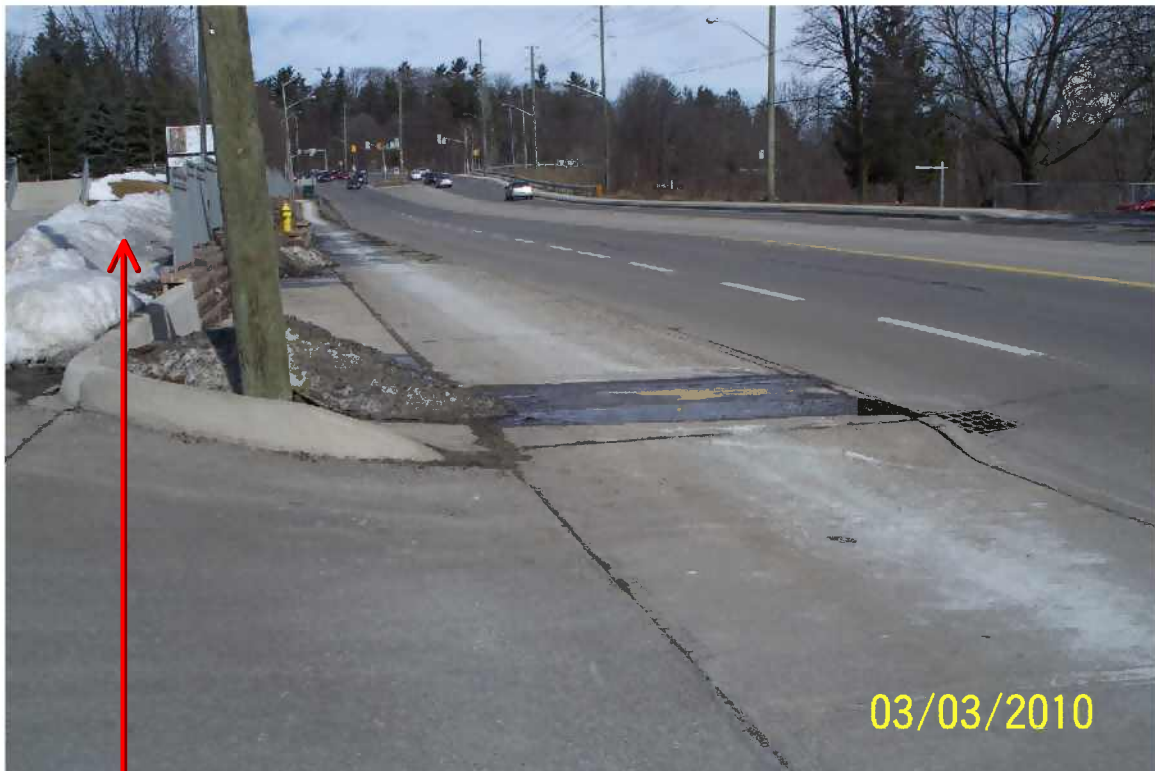
This photo illustrates salt laden snow in proximity to retaining wall.

Melting snow together with corrosive salt residues would actually drain into the retaining wall through holes drilled for railing.

This influenced deterioration from the interior of blocks as well.

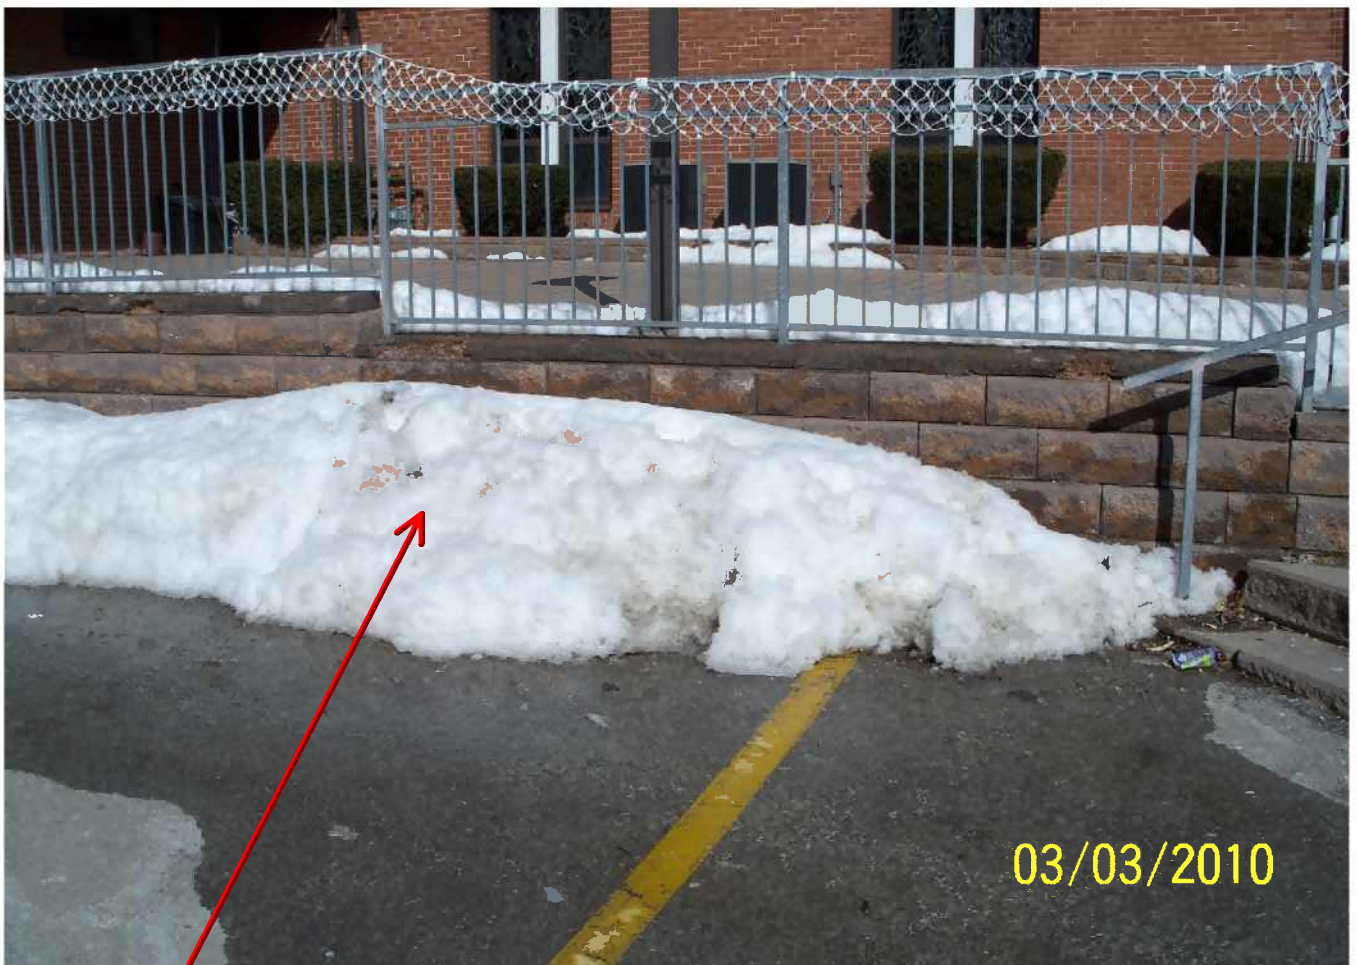
Observe salt laden snow pushed against retaining wall.

Imagine the block absorbing corrosive moisture from the salty snow.

Imagine the moisture in the block re-freezing over night and then expanding like a bottle of frozen water in your freezer. This natural freeze/thaw process, made worse under corrosive influence of salt, literally blew off the front face of the retaining wall blocks.

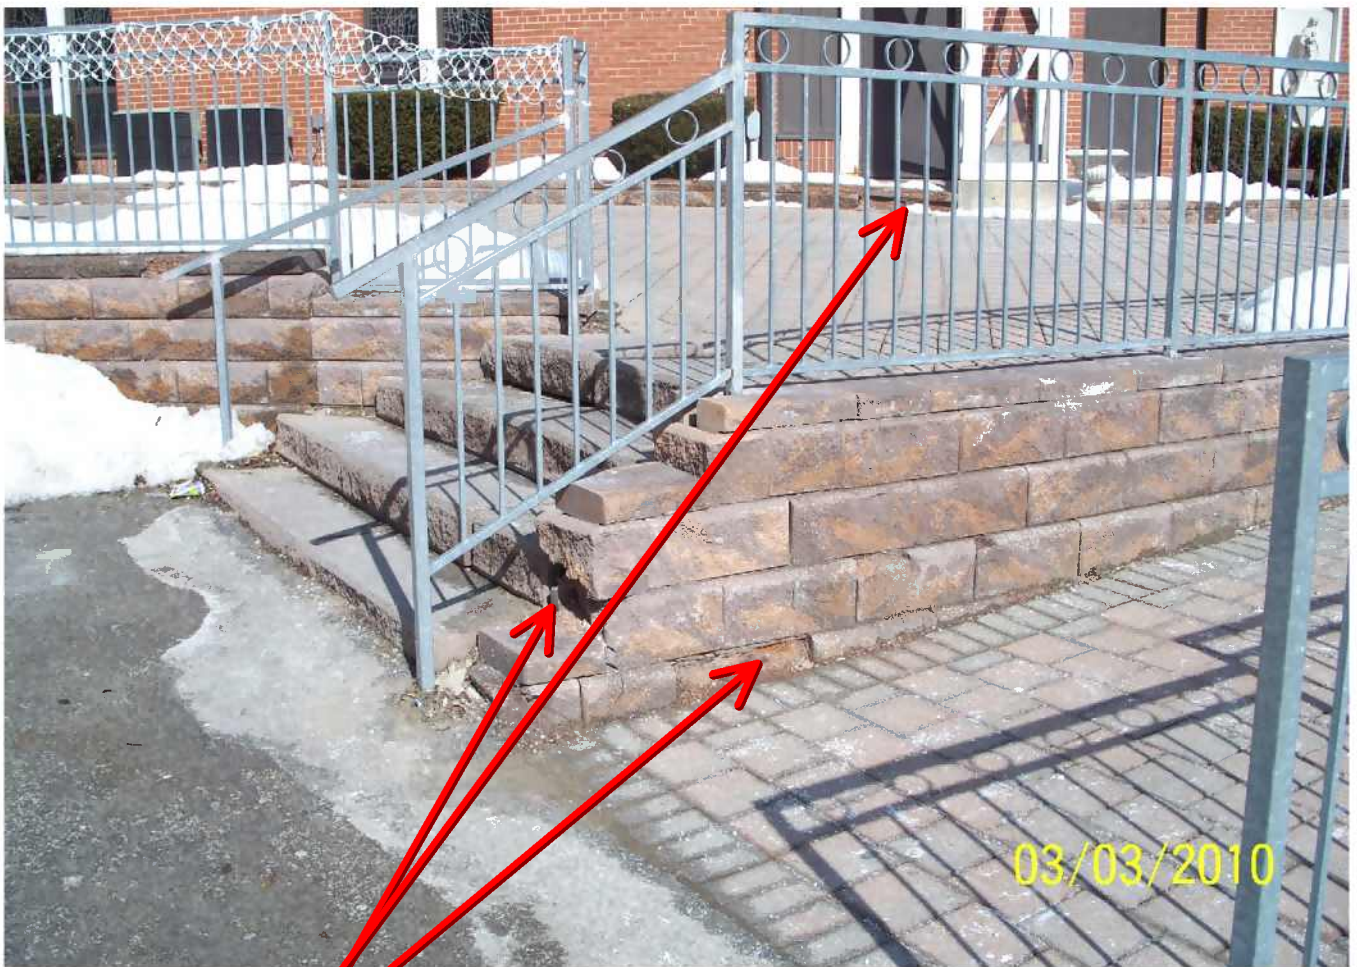
Photos showing more deterioration.
